ON SITE ... INSPECTIONS

This **CONFIDENTIAL INSPECTION REPORT** is the exclusive property of **ON SITE INSPECTIONS** and the client whose name appears herein. This report may not be reproduced without the written consent of **ON SITE INSPECTIONS**.

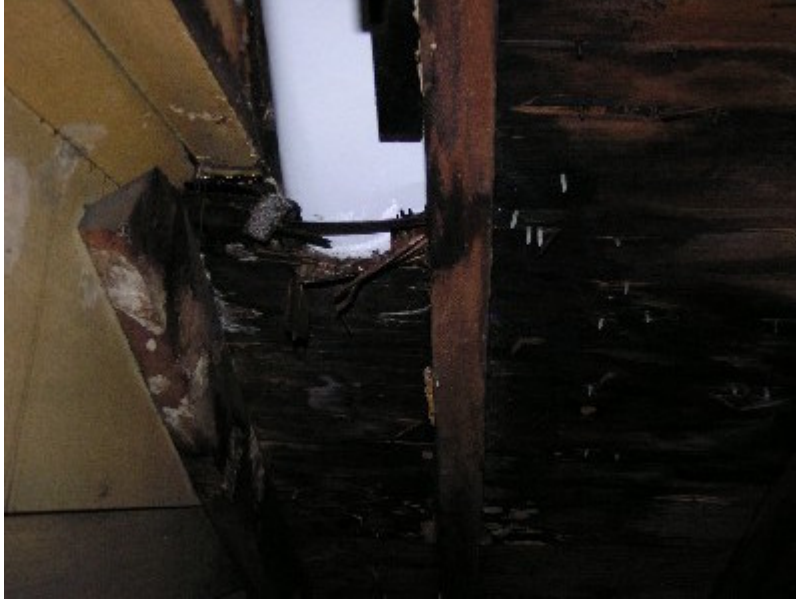
PICTURE 2 - north attic attach job---hole

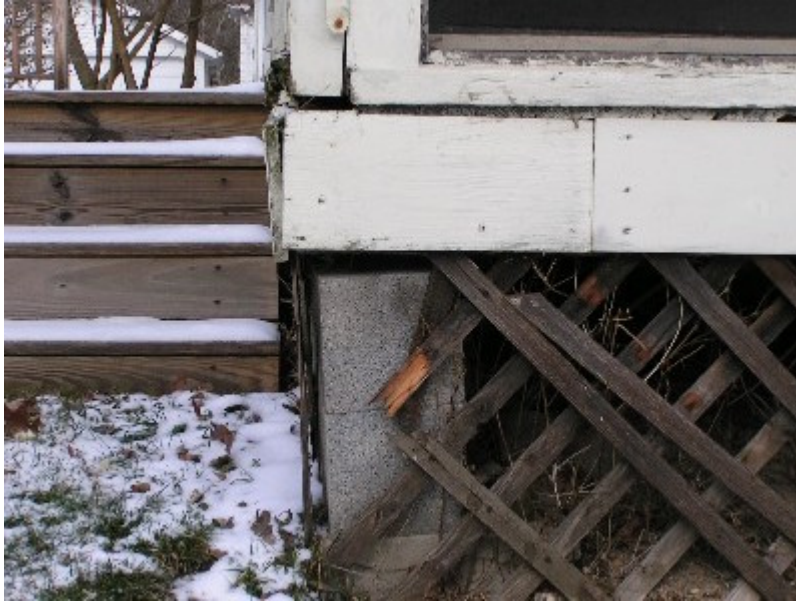
PICTURE 10 - south porch off pillar

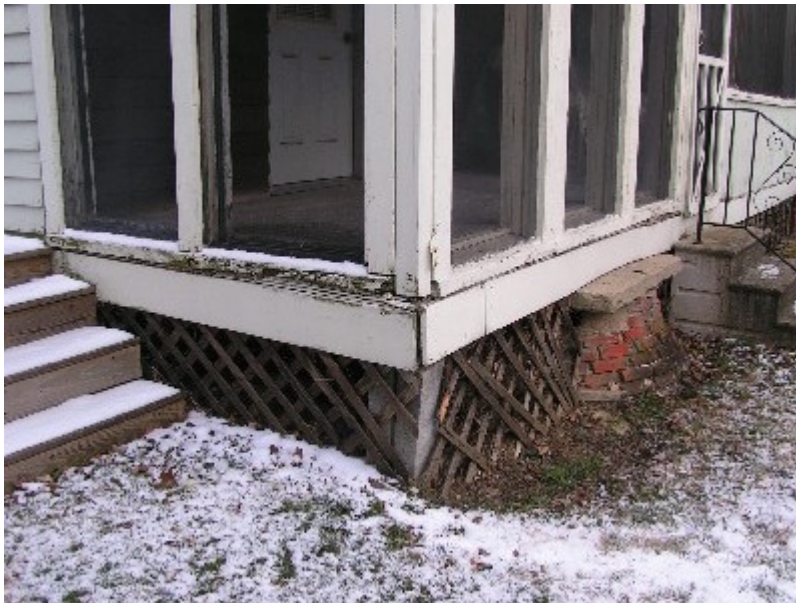
PICTURE 11 - south porch possibly supported by sistern

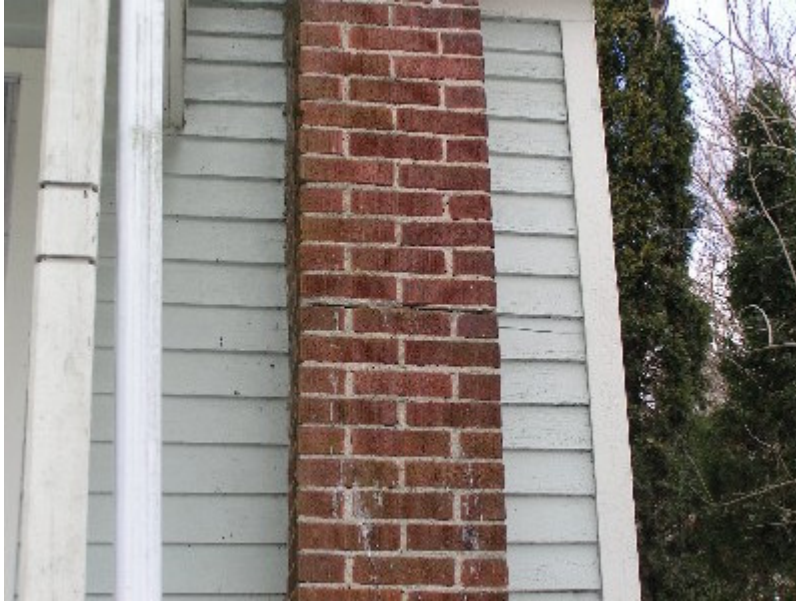
PICTURE 12 - crack in north chimney

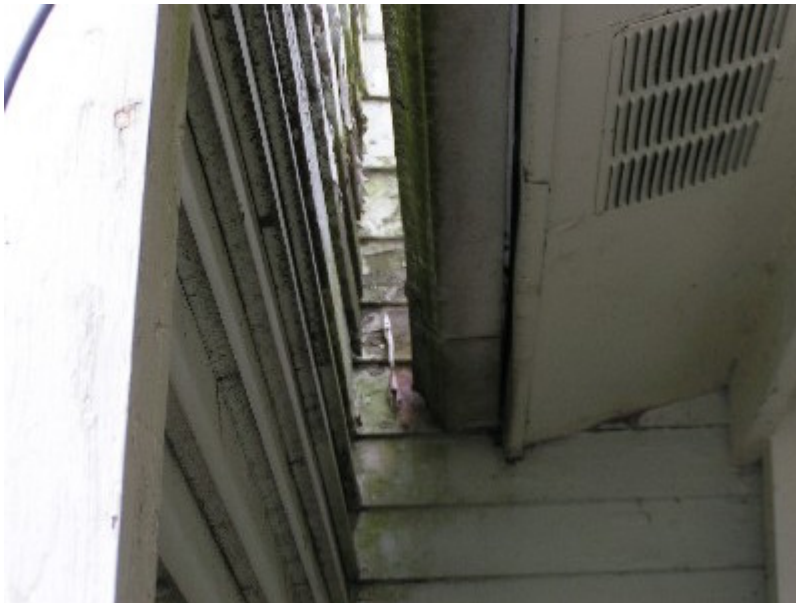
PICTURE 13 - rotted wood between north porch and house

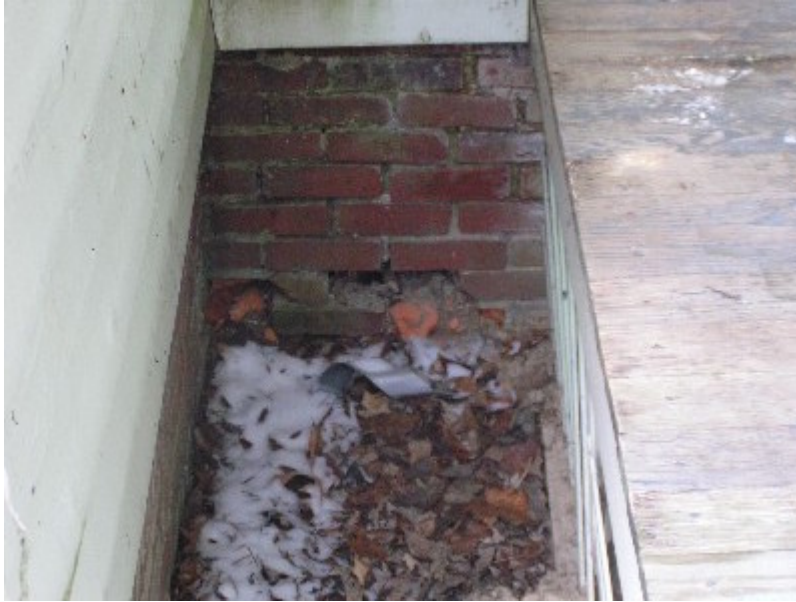
PICTURE 7 - area between north porch and house

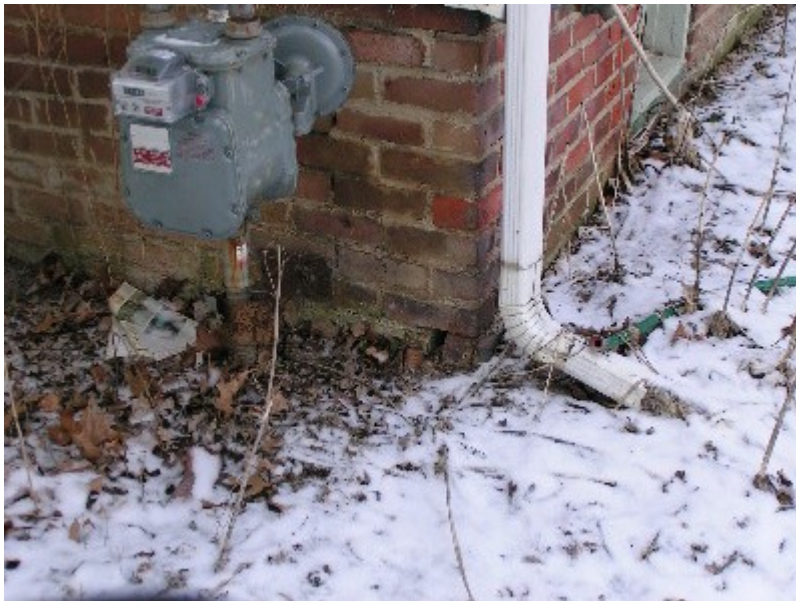
PICTURE 8 - foundation brick needs tuck pointing

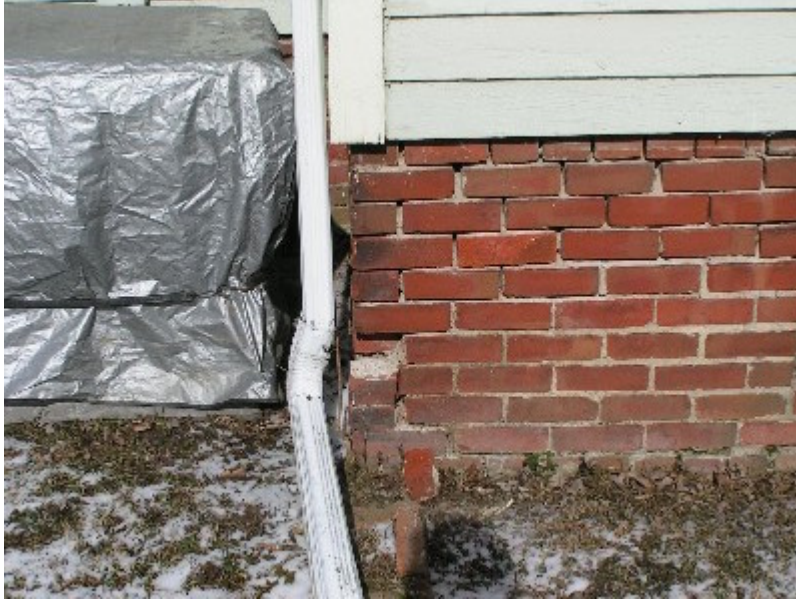
PICTURE 9 - brick work on foundation

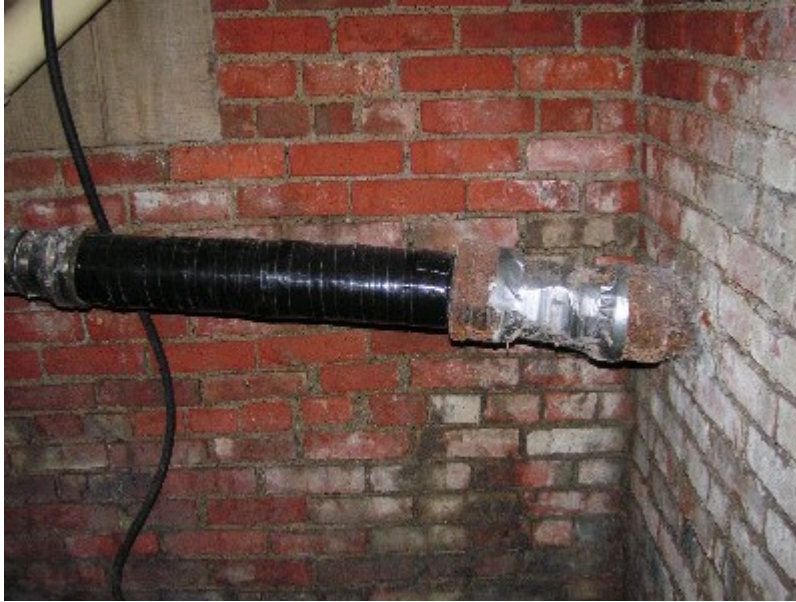
PICTURE 1 - sanitary discharge with duct tape

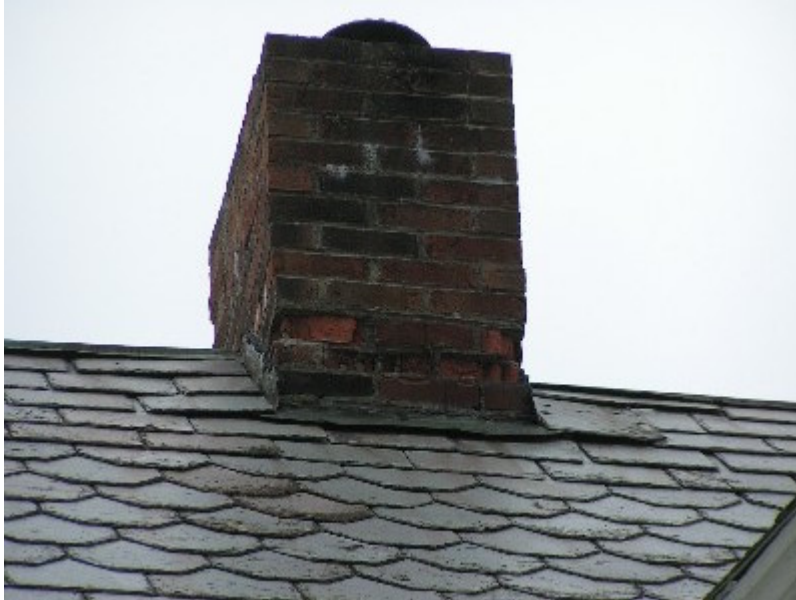
PICTURE 3 - main roof chimney--brick

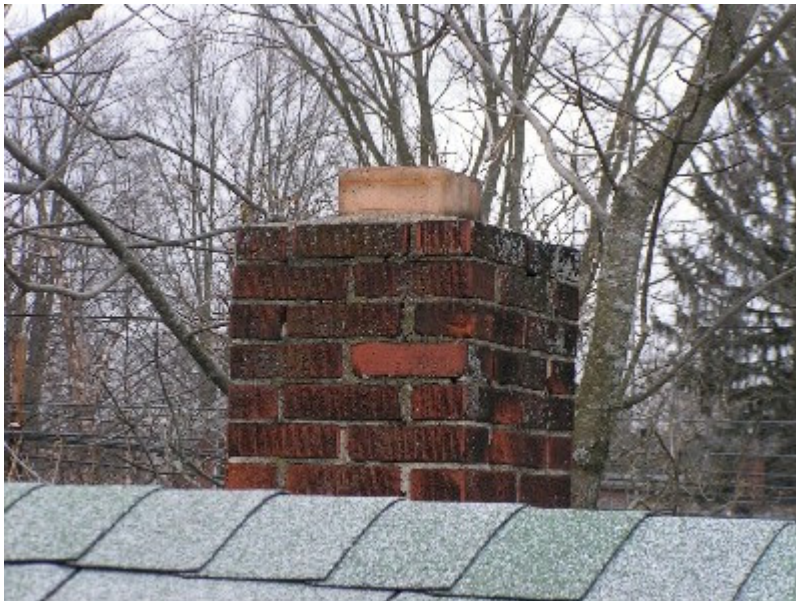
PICTURE 4 - north chimney brick

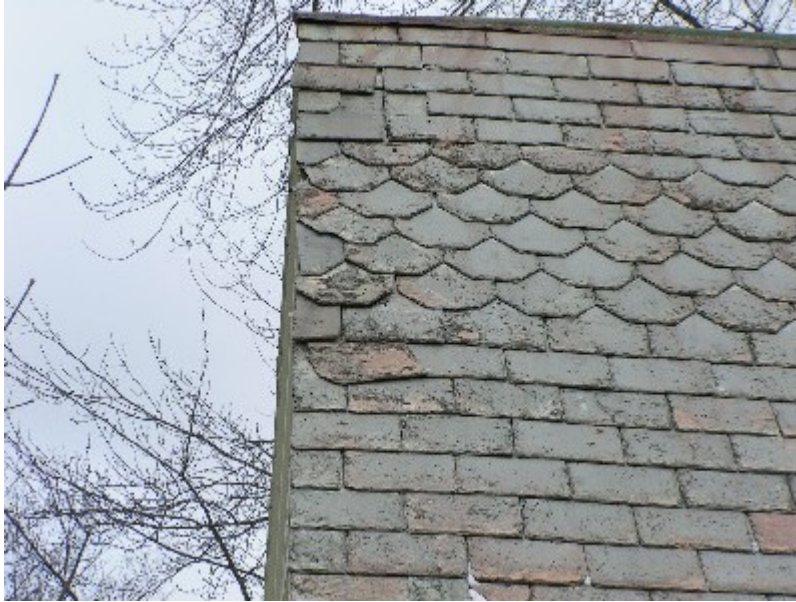
PICTURE 5 - late comig off

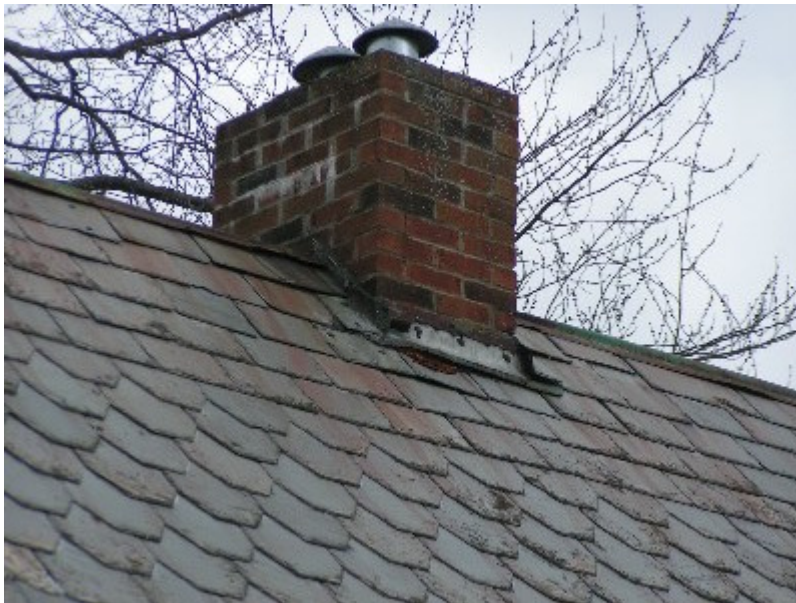
PICTURE 6 - flashing on main chimney
